## Are You Seeing These Problems?

**PROBLEM:****Piston ring dowel pin migration**

**Engine:** 1993 & up carbureted 185/200/225/250 HP Evinrude & Johnson Outboards (90 degree closed deck loopers)

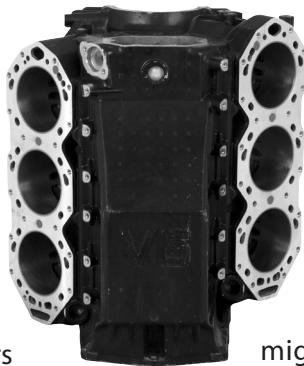
**Description:** Approximately 70% of the 90 degree closed-deck loopers we receive for machine work need repair because of piston ring dowel pin migration. This typically occurs when cylinder/piston temperatures are sustained at slightly over their threshold for extended running periods. As a result, the aluminum piston *lets go* of the steel dowel pin in the top ring groove. The pin will usually leave a notch or groove above the corresponding fingerport in the sleeve. In several cases, exhaust port damage will result from the top ring trying to exit out the exhaust port. This occurs when the dowel pin forces the top ring gap open while the pin is exiting the piston. Re-sleeving is required in 80% of these occurrences.

**Cause:** The cause of *dowel pin migration* in these cases is not a defective piston, but a lack

of water (coolant) in particular areas of the block, resulting in elevated temperatures in the cylinder/ piston.

**Repair and results – closed-deck cooling modification:** By modifying the cooling passages around the cylinders, dowel pin migration has been significantly improved. MarFab has been doing cooling modifications since mid-summer of 2001. We have had no returns with dowel pin migration thus far.

**Note:** The original OEM 1/4" red and/or white plastic water deflectors are removed and substituted as part of the cooling modification. The original deflectors **should not** be replaced.
