## SE121™ / SE122™ Oil Passage

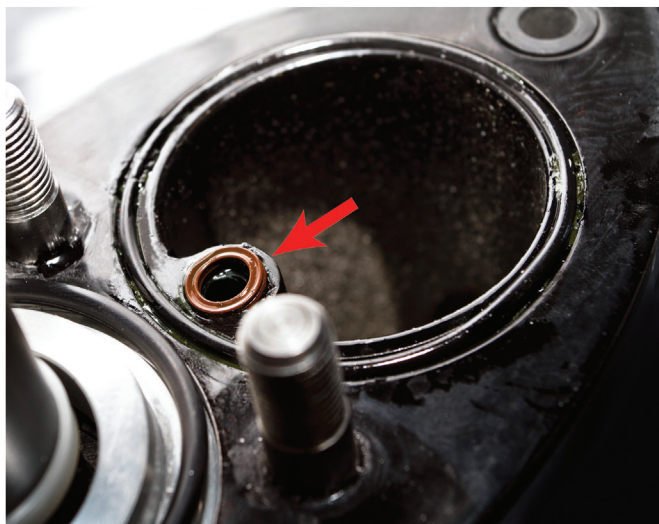
Be sure to pressure test the drive after the sealant has cured. Below is an image showing the oil passage hole. If the upper unit does not have a matching hole, then it will need to be plugged as well.

If replacing a Bravo One® Serial Number OF729999 and below, it will be necessary to plug the oil hole on the new lower unit. The best way is to tap the hole using a 1/4 -20 tap, and install a set screw coated in sealant. The set screw must be flush, or slightly recessed in the hole.

It is best to tap the oil passage while the drive is turned upside down to avoid getting any metal chips in the oil cavity. If you are not comfortable tapping the hole, you can use an RTV or silicone product to fill the hole.
