OIL PUMP ASSEMBLING AND INSTALLATION

14-4 MAINTENANCE

14-4 SHIFT IDENTIFICATION ALL UNITS EXCEPT BRAVO

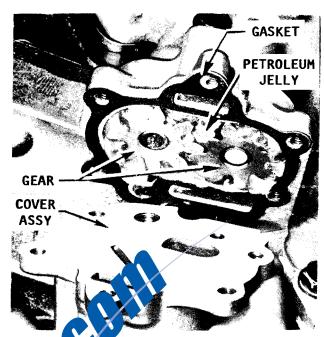
Serious of equences can result if the pump is not pack with roleum jelly at time of assembling.

In ess the pocket is packed with pretrome jelly, it may not prime itself when the ne is started

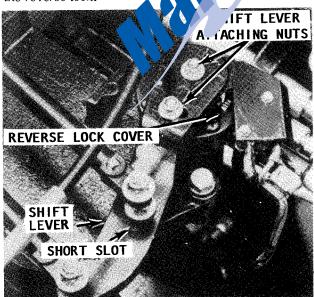
Short adjusting slot shift lever used on the following stern drive units: Model 120, 140, 165, 3780850 and above; Model 888, 225S, 233, 3784375 and a POPYRIGHTED MATERIAL thru 1684188.
